North West Estuaries Processes Reports

Dee Estuary

Prepared for **Sefton Council**

December 2013

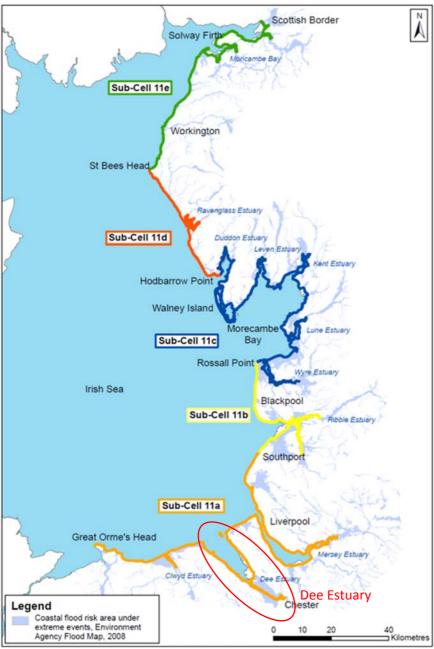
Figure 2.1 Overview of Cell 11 study area, showing SMP2 sub-cell frontages (source: Halcrow, 2010c).

The Dee Estuary is located within Liverpool Bay in sub-cell 11a, which extends from the Great Orme's Head (North Wales) to Southport, see Figure 2.1.

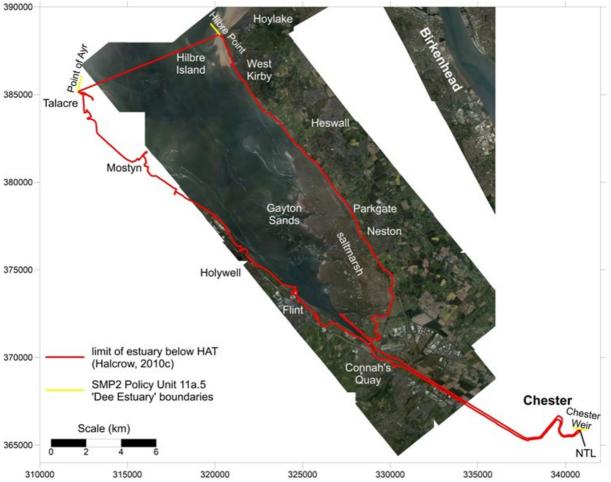
Figure 3.1 Limits of the Dee Estuary and SMP2 Policy Unit 11a.5.
